Facilities

The Mt. Fuji Weather Station facilities reflect its history, which began with the pioneering observations of Itaru and Chiyoko Nonaka in 1895, followed by the midwinter observations of Jun-ichi Sato in 1931. The station was manned for 72 years by the Japan Meteorological Agency from 1932 to 2004.

Mount Fuji Research Station (Elevation: 3776 m)

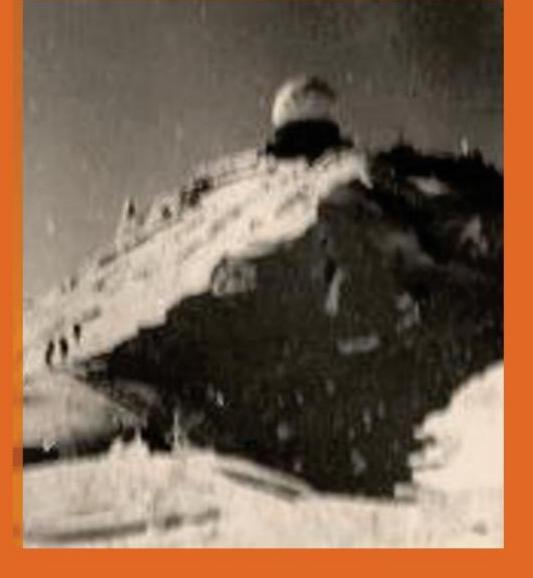
The four buildings are connected by a corridor and have a site area of more than 600 m². Buildings 2 and 3 are constructed of an aluminum alloy, similar to that used for the Shinkansen, for lightness and strength.

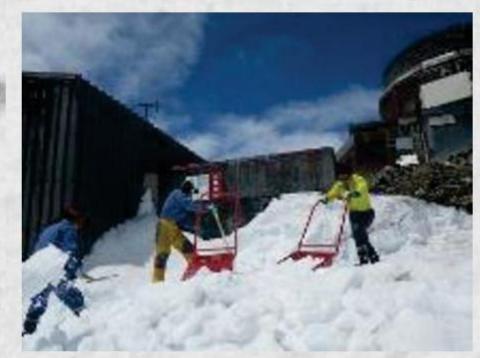
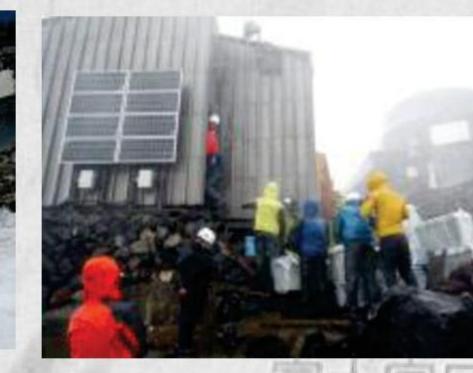
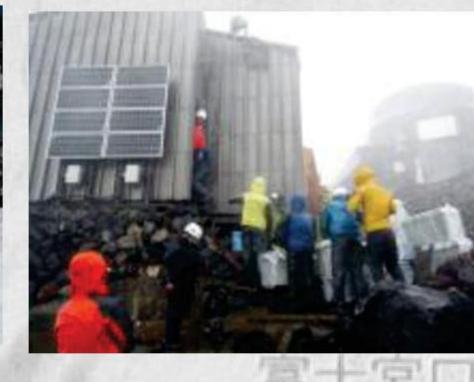
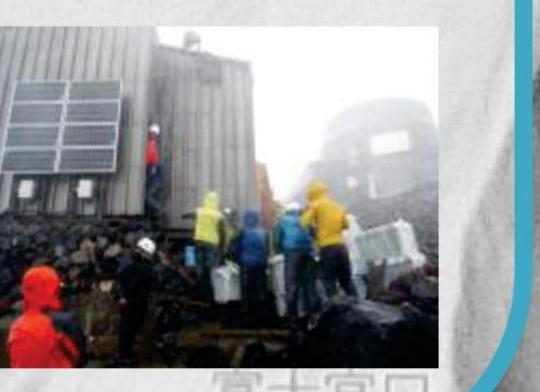
Professional climbers are employed as mountain crews during the summer season. They take care of the researchers and students who are susceptible to high-altitude sickness, which can be fatal. The climbers also install monitoring equipment and repair the power supply for the aging buildings.

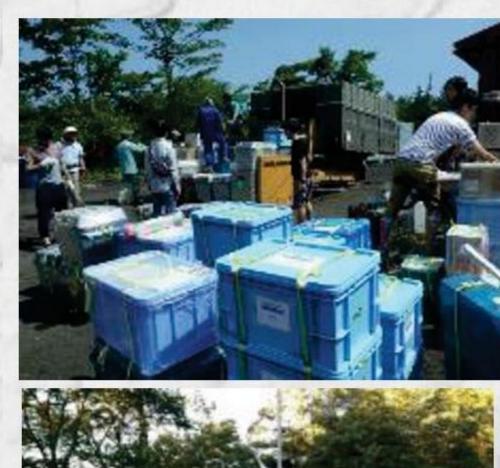
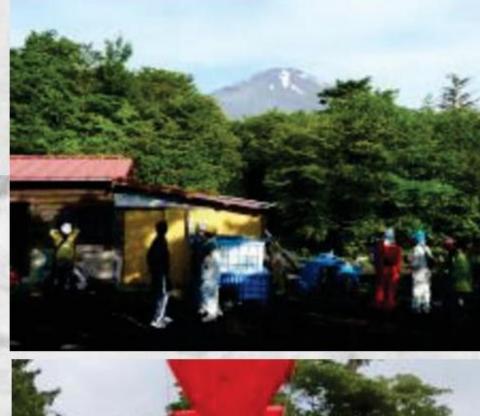
Tarobo Base (Elevation: 1300 m)

Tarobo at the southeast foot of Mt. Fuji is the base camp for researchers who climb to the top of the mountain. Bulldozers are used to carry large loads of equipment, food, and water.

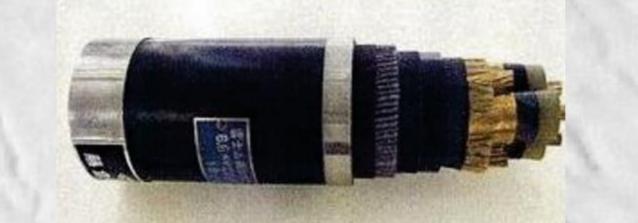
Underground cable.

An advantage of Mt. Fuji Research Station is that its electricity supply comes from a commercial electric source through 3.8 km of overhead wires and 7.2 km of underground cables. Power is also supplied to a public toilet on the summit and to a parking area at the foot of the mountain. The overhead cables can be damaged by lightning, snow, wind, and fallen trees. Repair and maintenance are difficult at high altitudes.
