### Chapter 2

### Electric Power Supply at Mt. Fuji Weather Station

### Tokyo Office, NPO Mount Fuji Research Station

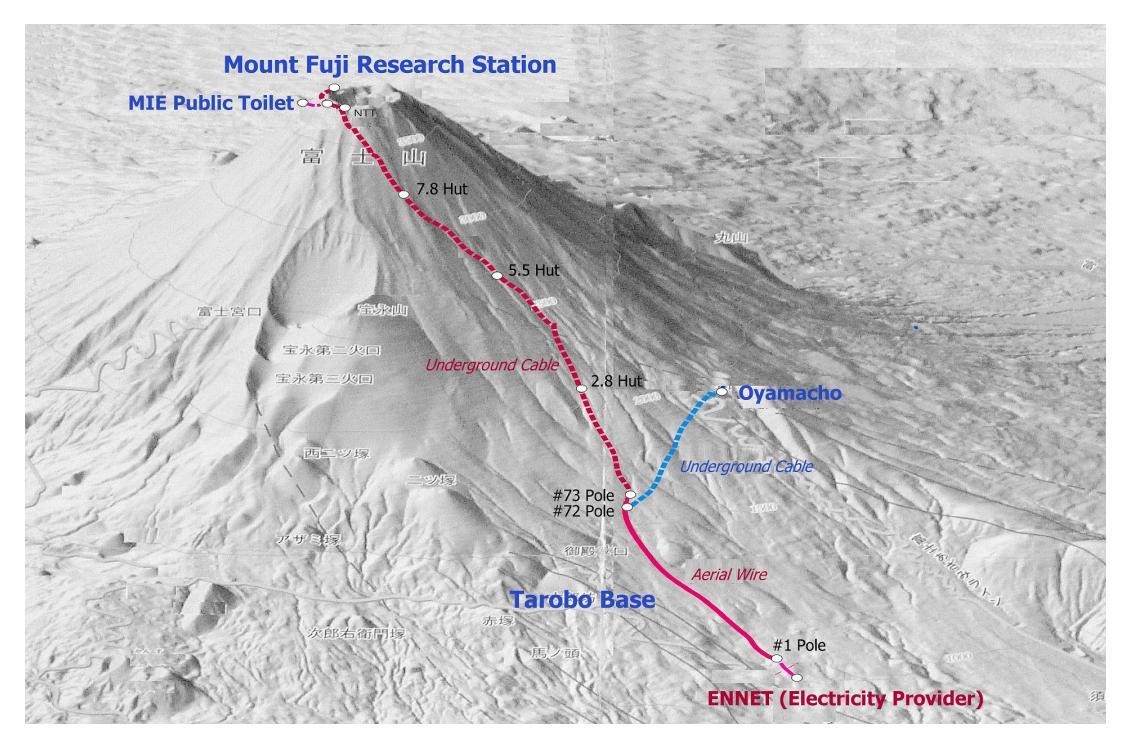
The wires were installed aerially, running from #1 electric pole at Gotemba at 1075 m a.s.l. to #73 pole at 1575 m a.s.l. and then underground to the weather station at Kengamine. Figure 2-1 shows the electric wiring system when we, the NPO Valid Utilization of Mt. Fuji Weather Station (NPO Mt. Fuji), rented the electric system in 2007 (red line).

Fig. 2-1: Electric Wire System at Mt. Fuji Weather Station

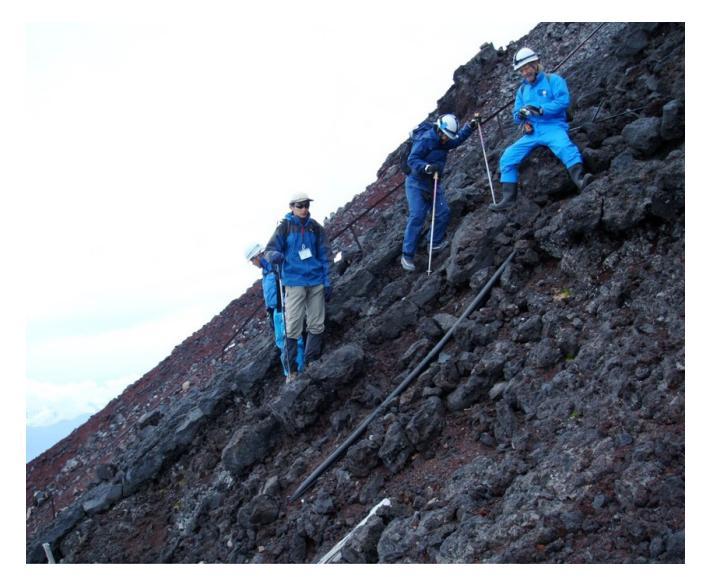
Fig. 2-2: Checking the underground electric wire near 3585 m a.s.l. (taken July 2007 by the mountain crew)

Fortunately, at this time, chief electrical engineer Tomohisa Okoda, who had just retired from JMA, joined NPO Mt. Fuji, allowing us to maintain the same expert in the same position when we started our logistics. Figure 2-2 shows the engineers of Kandenko Co., Ltd. checking the underground wires near 3585 m a.s.l.

Mr. Okoda had had an unfortunate experience the year before when almost 1 week of commercial electricity supply was lost. After this, the particularly fragile huts on Umanose and #64 pole were checked with special care (Fig. 2-2). Therefore, in 2007, the connection was successful with simultaneous switching at the summit and #1 pole. We felt a sense of accomplishment when, on July 9, 2007, we could announce to our members that we had successfully turned on the electricity. With this, we felt ready to start our summer research campaigns. Over the last 10 years, except for 2015 when the summer campaign was delayed 1 week because of an underground wire accident at the shrine (Table 2-1), we have been very lucky to have successful connections at the beginning of every campaign. We greatly appreciate that we have been able to work with the know-how acquired through relationships with individual members of JMA.

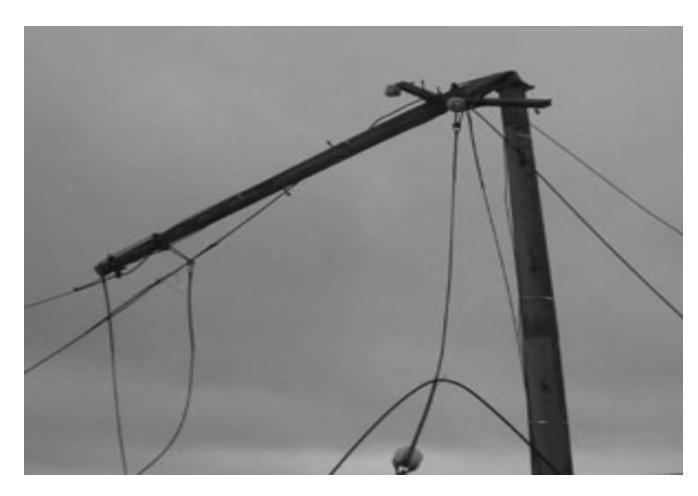
Fig. 2-3: Electric poles damaged by heavy snow in 2008

However, bad news came in February that the Echo Rangers had found on their patrol that 12 poles (#58-64 poles) had been damaged by heavy snow. We discussed repairs with JMA, but as they were no longer using the commercial electricity, they were no longer responsible for such repairs. As an NPO, we therefore needed to fund the repair bill of almost 5 million yen ourselves if we were to continue using the commercial electricity supply. Given that the forthcoming summer research campaign would be impossible without commercial electricity, after much deliberation and with much reluctance, NPO members allocated some of the valuable research funds toward repairing the poles, which are now listed as NPO assets. Fig. 2-3 shows the electric poles damaged by heavy snow in 2008.
